# Manhole Inspection Summary

Manhole # S35Q\_\_017MH

Insp Date: **3/20/08 2:39 PM**

**Location** Address: **1024 S. HANOVER ST**

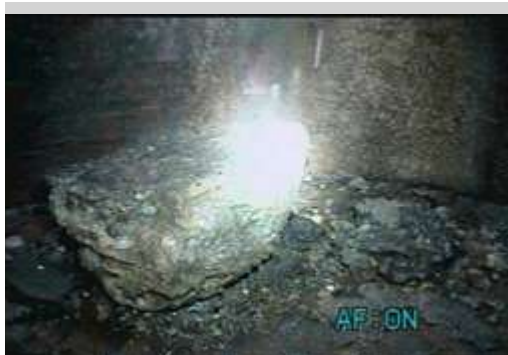
Defect 3

Condition: ☐ Sound ☐ Cracked ☐ Root Intrusion ☐ Deteriorated ☐ Leaks ☒ Debris

Bench debris

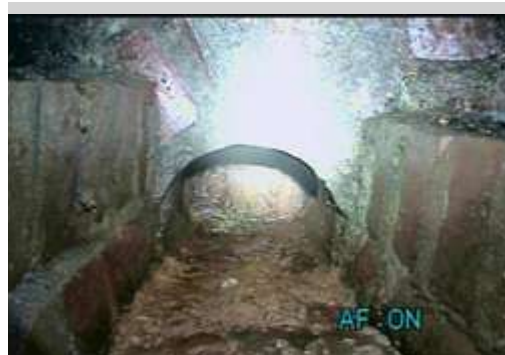
Defect 4

Condition: ☐ Sound ☐ Cracked ☐ Root Intrusion ☐ Deteriorated ☐ Leaks ☒ Debris

Channel Debris

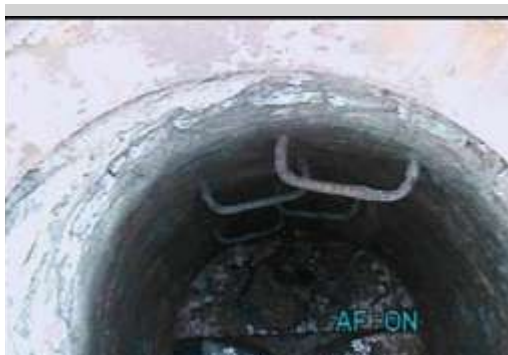
Defect 2

Count: **4** Missing: **0** ☒ Corroded

steps

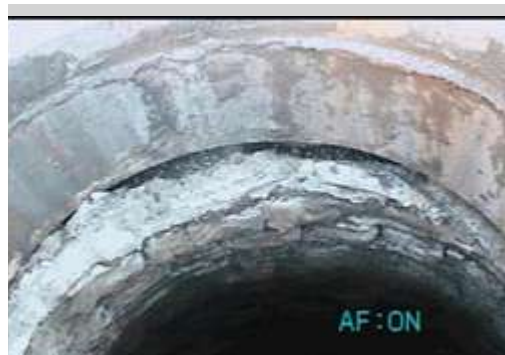
Defect 1

Offset: **3** (in.)

Condition: ☐ Sound ☐ Cracked ☐ Root Intrusion ☒ Loose Brick ☒ Deteriorated

Loose Bricks, Deteriorating Chimney,  
Frame Adjustment, 3" Offset

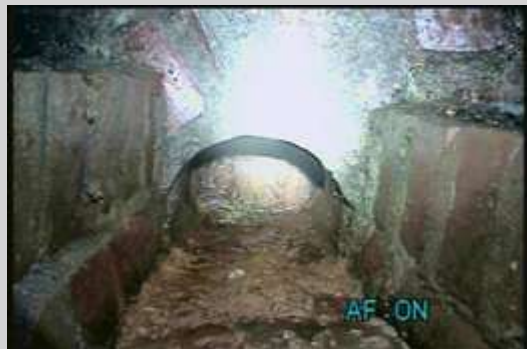
9 O'Clock Inflow

Deposits: ☐ None ☐ Mud ☒ Sludge ☒ Debris ☐ Grease

Silt Depth: 3 (in.) Deposits Extent: Medium
